# Manhole Inspection Summary

Manhole # S43AA\_003MH

Insp Date: **3/4/10 12:59 PM**

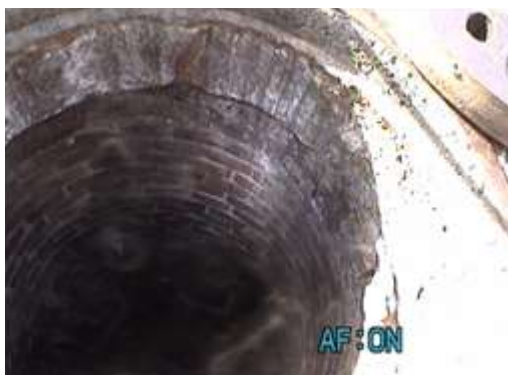
Defect 2

**Frame** Offset: **2** (in.) Condition: ☐ Sound ☐ Cracked ☒ **Leaks**

Frame leaks

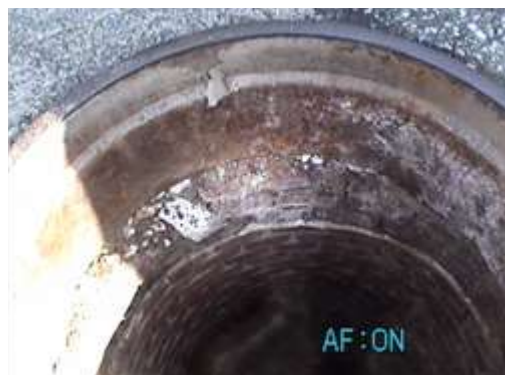
Defect 1

Condition: ☐ Sound ☒ **Cracked** ☐ Root Intrusion ☐ Loose Brick ☐ Deteriorated

Infiltration: ☐ None ☐ Joint ☒ **Cracks** ☐ Mortar ☐ Roots ☒ **Wall**

Infiltration
